Periodic Inspections of Dolosse on Crescent City Breakwater, Crescent City, California

Report 1
Monitoring Data for Period 1989-1993

by Dennis G. Markle, Jeffrey A. Melby, WES Thomas R. Kendall, San Francisco District

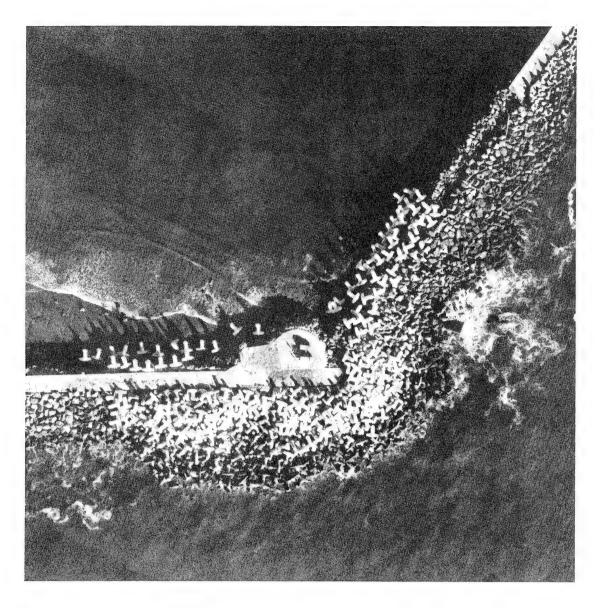
In 1986, 760 fiber-reinforced, 42-ton dolosse were cast, and 680 placed on the sea-side slope of the main stem from sta 34+00 to approximately 105 ft beyond sta 37+00. The remainder of the units were stockpiled on the harbor side of the structure. Figure 2 shows the plan view geometry of the dolos rehabilitation work as recommended by the 1985 physical model investigation. Twenty of the 680 dolosse placed on the sea-side face were instrumented to collect moments and torques induced at the fluke-shank interface on one end of the dolos and selected dolosse out of these 20 contained accelerometers to monitor dolosse motion. The instrumented units were placed near the center of the repair area. Four of the dolosse were placed in the bottom layer and the remaining sixteen were positioned in the top layer. The dolosse were linked to a land-based data acquisition system. Wave monitoring devices were placed at locations seaward of the dolos repair section and pressure transducers were positioned within the breakwater to monitor internal pressure fluctuations. During the two years following the repair, a wealth of incident wave conditions and dolos moment and torque data were collected. Details of the prototype dolos instrumentation and data acquisition and analysis work are presented in Howell et al. (in preparation). An aerial view of the rehabilitated structure is shown in Figure 3. Instrumented units can be seen in the darker area at approximately the center of the sea-side slope.

Figure 3. December 10, 1986, aerial view of Crescent City breakwater's dolos rehabilitation

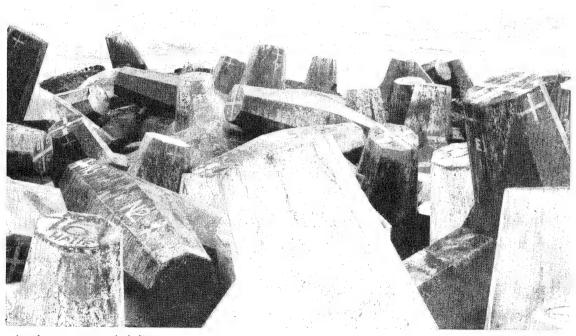
Figure 7. Targeting of dolosse

underlayer had only one target placed on the end of an exposed vertical fluke on each unit. Figure 7 shows examples of targets on an uninstrumented dolos and instrumented dolosse. The targets began as painted crosses and later evolved to the circular targets to improve photogrammetric accuracy. Prior to each flight to obtain aerial photographs, all targets were inspected and retouched as necessary to improve their visibility in the photographs. Additional details on dolos and ground control targeting are provided in Howell et al. (in preparation).

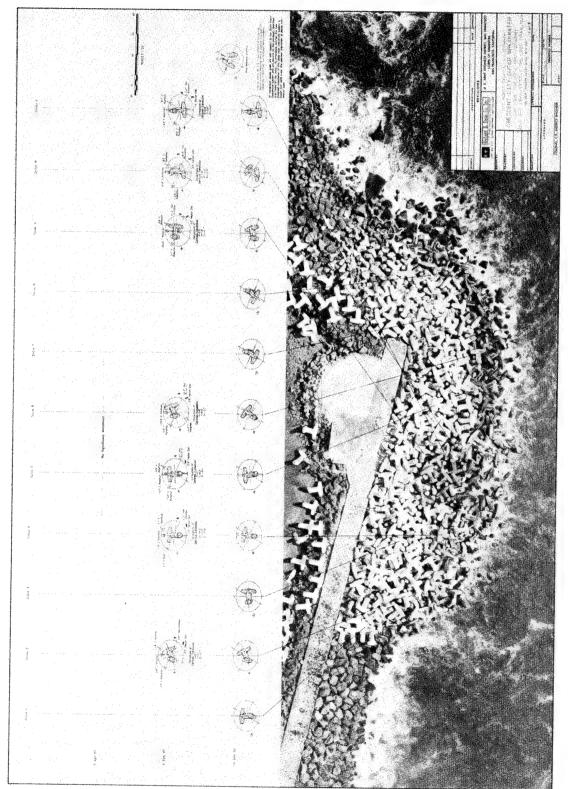
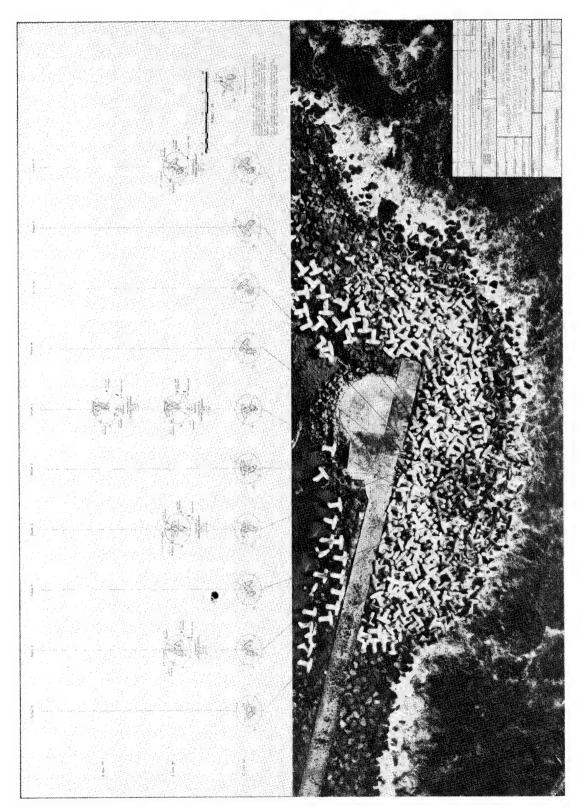
Figure 11. Initial orientation and first season movement of targeted dolosse (Continued)

Based on the aerial surveys, if any target on a dolos experienced relative movement of at least 0.5 ft or cumulative movement equal to an integer multiple of 0.5 ft, these were considered significant or threshold movements and seasonal reports were generated. Three-dimensional exploded views of the dolosse meeting the threshold were plotted on oblique photo maps. Example photo maps from the end of the 1987 season are shown in Figure 11 (taken from Howell et al. (in preparation)). The figure shows the original orientation of each dolos (with three targets) that is unbroken (note that instrumented dolos R was broken during placement and thus is the only three-targeted unit not shown on Figure 11). Eleven dolosse reached their first threshold movement and one of the same units reached an additional threshold during the first season, 1986-87. A season has been defined to run from fall of one year to the spring of the next. The season into which each aerial flight fell is

delineated in Table 1. During the 1987-88 and 1989-90 seasons, two and one additional units, respectively, reached a threshold. No units reached a threshold during the 1988-89 and 1990-91 seasons. Units K and O reached a threshold for the first time during the 1991-92 season. No targeted unit movement reached a threshold during the 1992-93 season.

Sixteen units (1,2,3,4,5,6,A,B,C,E,G,K,L,M,P,O) out of the 22 units with three targets met at least one threshold. Four of these units (B,C,L,P) met a second threshold and one of these four (L) met a third threshold. Oblique photo maps showing dolos movement for the 1986-87, 1987-88, and 1988-89 seasons are presented in Howell et al. (in preparation). Maps for the 1989-90 season are presented in Figure 12. Figure 13 covers both the 1991-92 and the 1992-93 seasons. Maps for the 1990-91 season are not included, as no threshold movement was noted. Figure 11 is provided to show initial location and orientation of the targeted units. Figures 12 and 13 can be used to see what date and which targeted units reached threshold movement during the MCCP study. Details of cumulative movement for each unit reaching threshold during the MCCP study are shown in Figures 14-16. Similar drawings are presented in Howell et al. (in preparation) for units reaching threshold movement during the first three seasons.

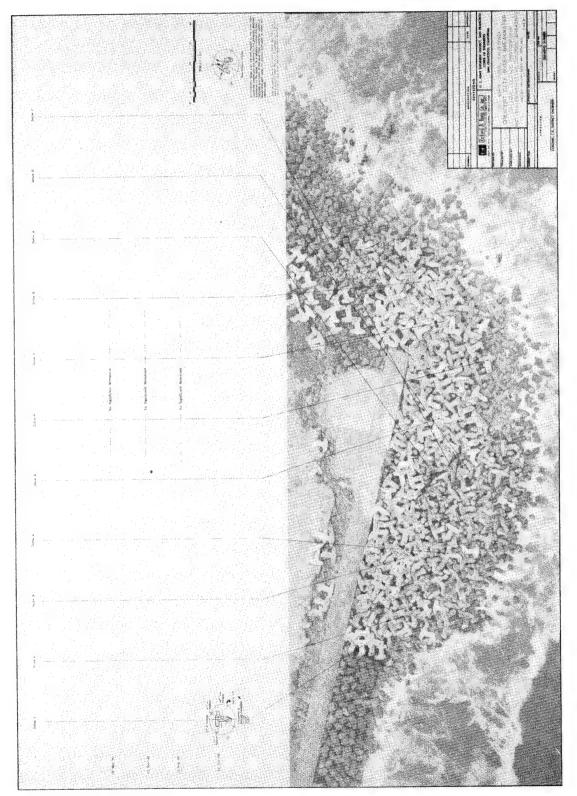
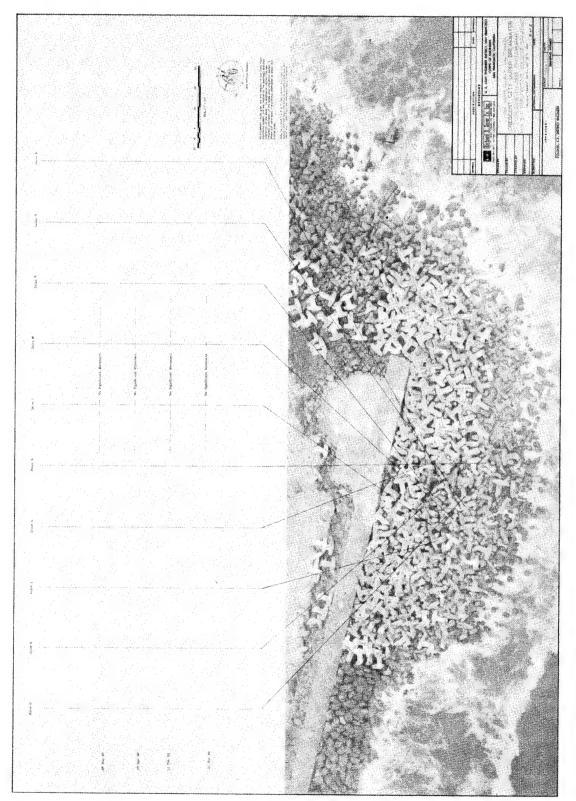
Figure 12. Targeted dolos movement for 1989-90 season (Continued)

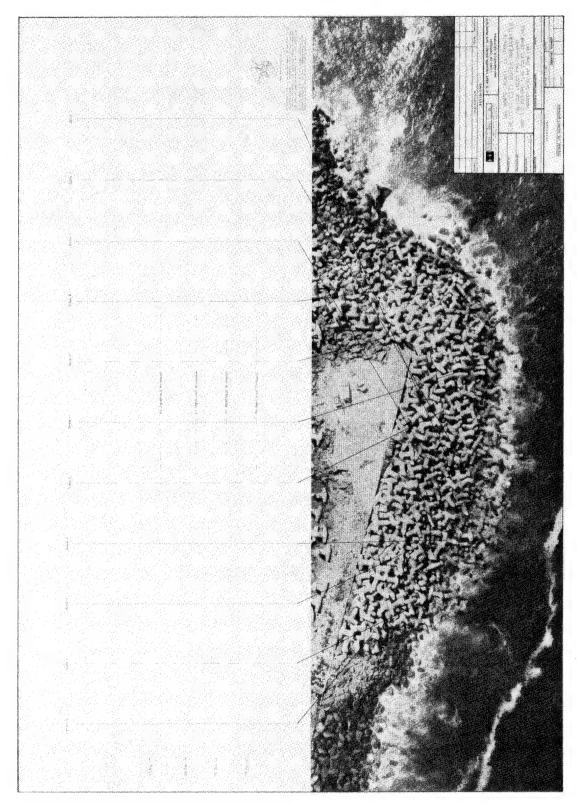
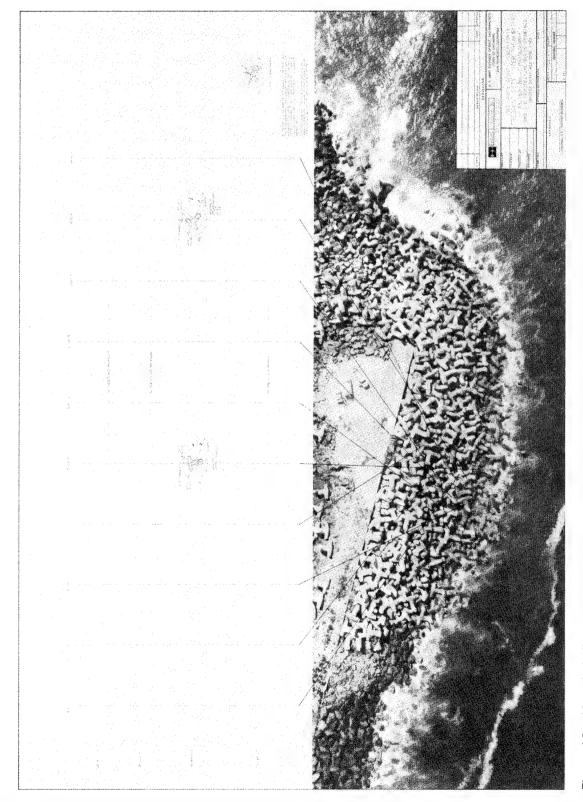
Figure 13. Targeted dolos movement for 1991-92 and 1992-93 seasons (Continued)

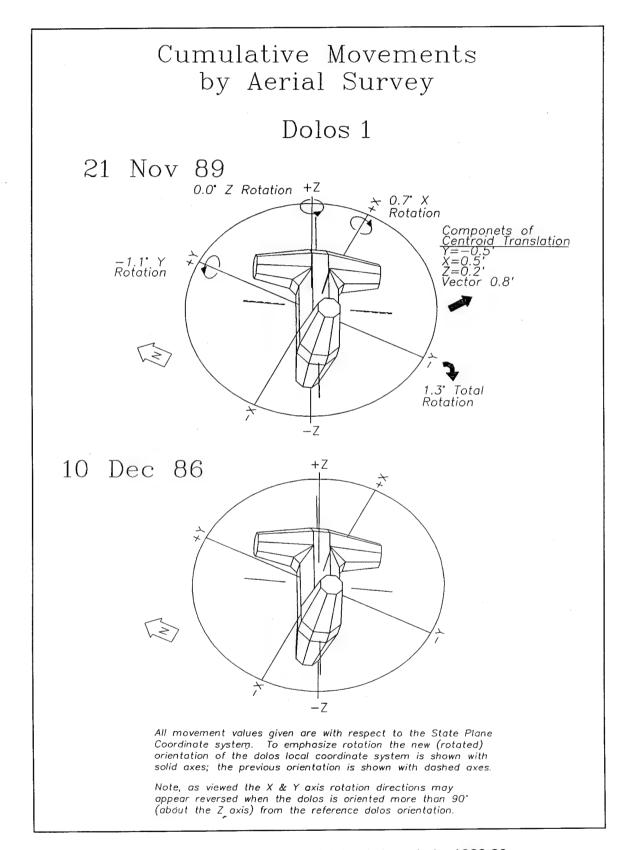
Figure 14. Details of cumulative movement of dolos 1 through the 1989-90 season

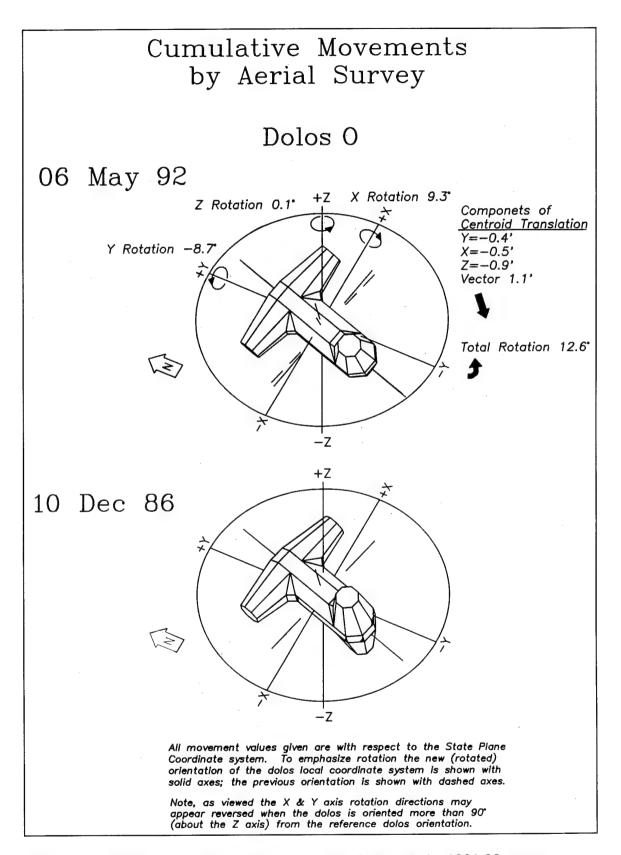
Figure 16. Details of cumulative movement of dolos O through the 1991-92 season

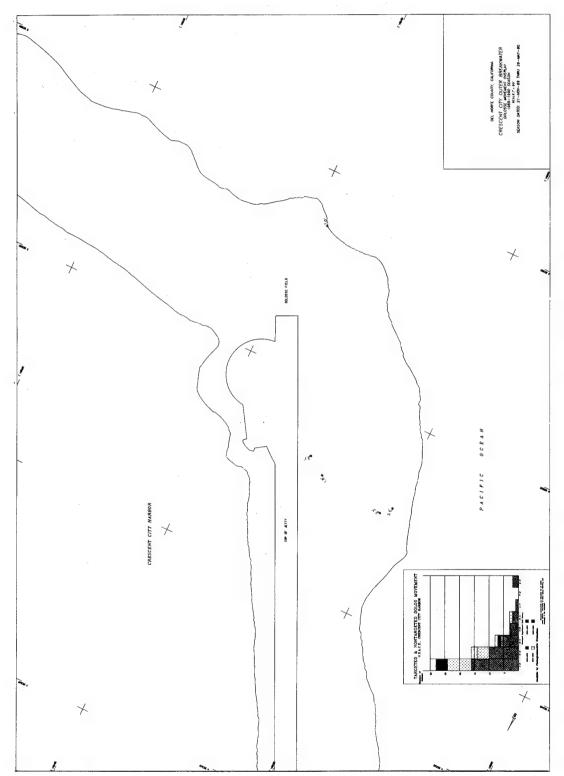
Figure 17. Targeted and non-targeted dolos movement exceeding 1.0 ft from 21 November 1989 through 26 May 1990

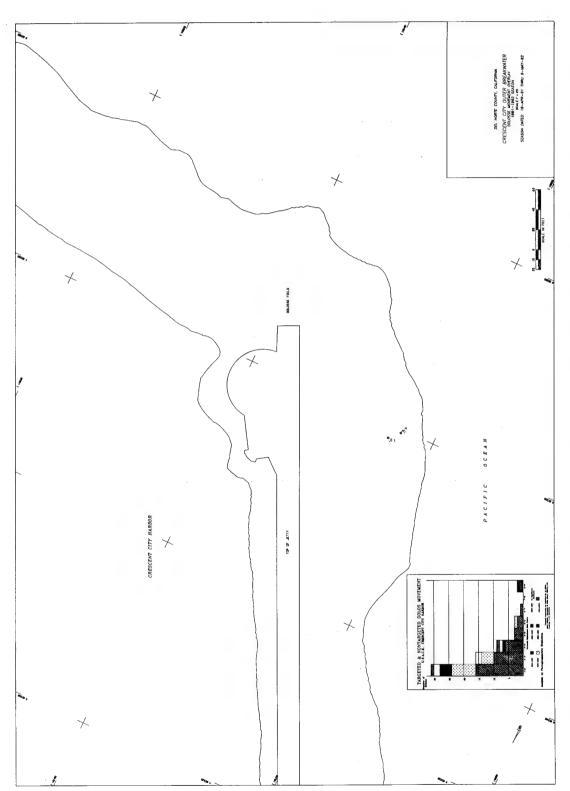
Figure 18. Targeted and non-targeted dolos movement exceeding 1.0 ft from 18 April 1991 through 6 May 1992

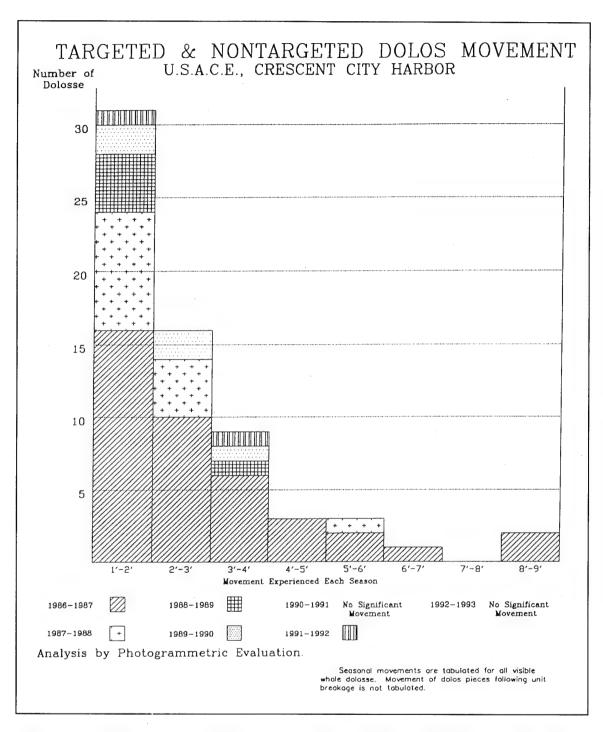
Figure 19. Targeted and non-targeted, whole dolos movement breakdown by magnitude and season

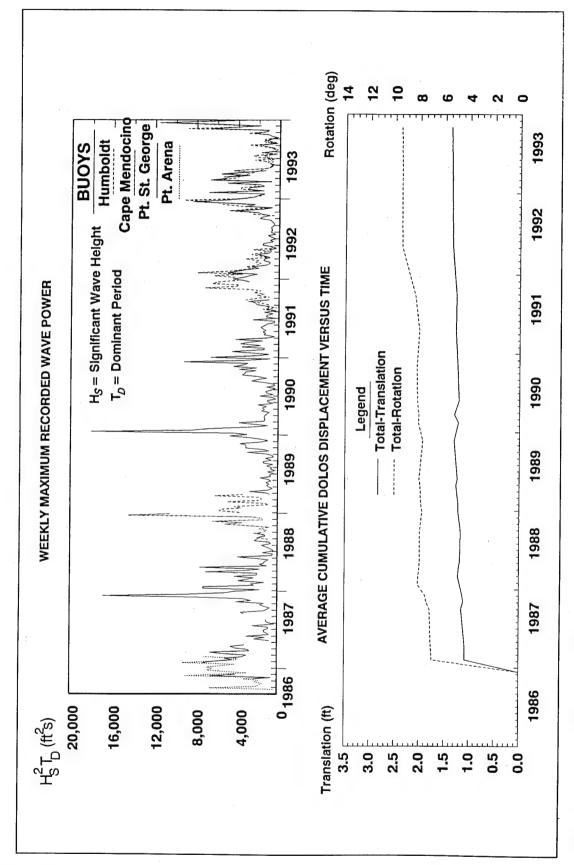
Plots of maximum weekly wave power and average cumulative dolos movement versus time Figure 20.

Figure 20(a) presents time series plots of wave power calculated for the BOO. Figure 20(b) presents dolos displacement plots based on aerial survey data. For dolosse with three targets each, the average of the cumulative vectorial translations of the dolos centroids and the average of the maximum cumulative rotation of a point on the surface of the dolos about the dolos centroid are plotted as a function of time.

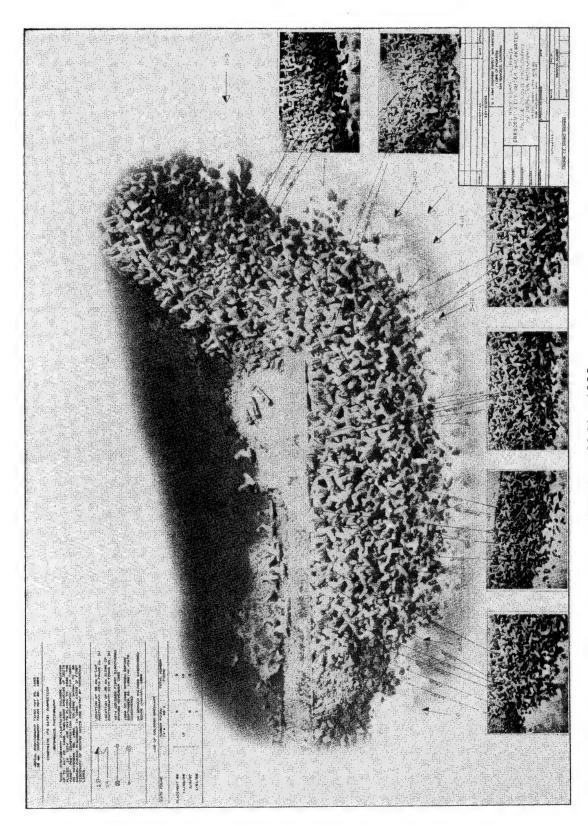
Figure 21. Reproduction of breakage survey sheet from 22 May 1993

Eighteen helicopter inspections were made between October 1988 and May 1993 to inventory dolos armor unit breakage. These surveys were conducted subsequent to high-resolution aerial photography flights. Oblique, 35-mm photographs were taken close up on unit breaks as well as far field to capture the condition of the entire dolos field from different oblique perspectives. A sampling of the 35-mm photographs was mounted on the most recent 28-in. by 40-in. rectified photo map or oblique aerial image of the entire dolos field. The dolos breakage summary on each inventory sheet is separated into broken dolosse from the 1974 and 1986 construction. The date when each broken dolos was first noted and entered into the inventory also is listed. In addition to the inventory sheet, a 35-mm photo album was assembled for each inventory, and oblique orientations of the camera are indicated on the inventory sheet for a cross section of the photographs. The survey sheet from 22 May 1993 has been reduced and is included as Figure 21. Full-size sheets and photo albums from each survey are on file in the authors' offices. Table 2 lists pertinent facts for each inventory. Through 22 May 1993, aerial inspections have revealed fifteen and nine broken dolosse from the 1974 and 1986 constructions, respectively.

accounts for 48 breaks on 47 reported units. Thirty-three breaks were believed to be moment-induced and six resulted from torque loading. The remaining breaks were not classified.

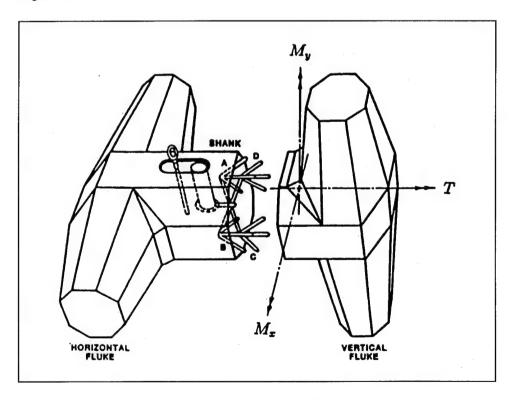
Figure 22. Prototype internal dolos instrumentation and measurement definition (after Melby and Howell (1989))

manner that two moments and a torque could be measured at the fluke-shank interface of one end of the dolosse (Figure 22) (Melby and Howell 1989). These two moments and torque could in turn be used to calculate a maximum principal stress at the dolos' fluke-shank interface. This method was first presented by Burcharth and Howell (1988). The maximum principal stresses calculated as a function of time for the prototype data can be separated into stresses induced by pulsating wave loads and static loads. No impulse stresses associated with impact loads between units were found in the prototype data. Static loads are felt to be the result of unit self weight and loads from adjacent units caused by interlocking and wedging. Stresses associated with static loads were defined as the mean of each 20-min data signal. The data signal minus the mean provided the maximum principal stress associated with pulsating wave loadings. A 4-day window was applied to the static stress signal to calculate the average maximum principal stress for each dolos. This averaging scheme helped to remove longer period cyclic variations associated with tidal cycles and daily heating and cooling cycles. After close scrutiny of the CCPDS static stress data, it was felt that some of the extreme values could not be valid and these data are not presented in Figures 23 and 24. Figure 23 presents the average maximum principal stress associated with static loads for each dolos during a given period of time throughout the CCPDS and MCCP study. Each row of data was averaged and these data are plotted versus time in Figure 24. A best linear fit was calculated and is also presented in Figure 24.

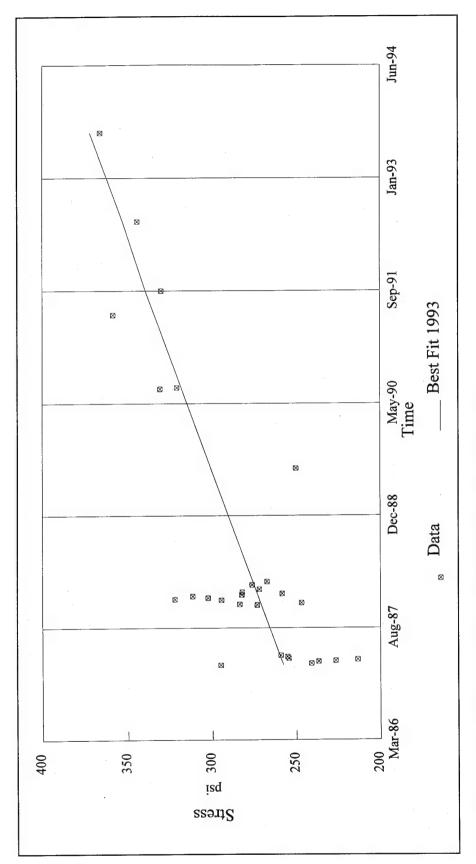
Figure 24. Average maximum principal stress associated with static loads

One of the primary findings from the field monitoring is that the most significant structural design parameter for these large dolos is static stress. Subtle movement in the dolos matrix can cause shifts in dolos boundary conditions which, in turn, produce a change in dolos static stress. Field data on dolos movement, static stress, and breakage should continue to be collected in order to better understand the long-term nesting behavior of large dolosse.

- d. As of the spring of 1993, dolos breakage seemed to have subsided and was at a level that was not a major concern. However, with the question of rising dolos static stresses, close inspections following significant storm events are recommended.
